US Army Corps  
of Engineers®  
Engineer Research and  
Development Center

## **Periodic Inspections of Hilo, Kahului, Laupahoehoe, and Nawiliwili Breakwaters, Hawaii**

Armor Unit Monitoring for Period 2001-2005

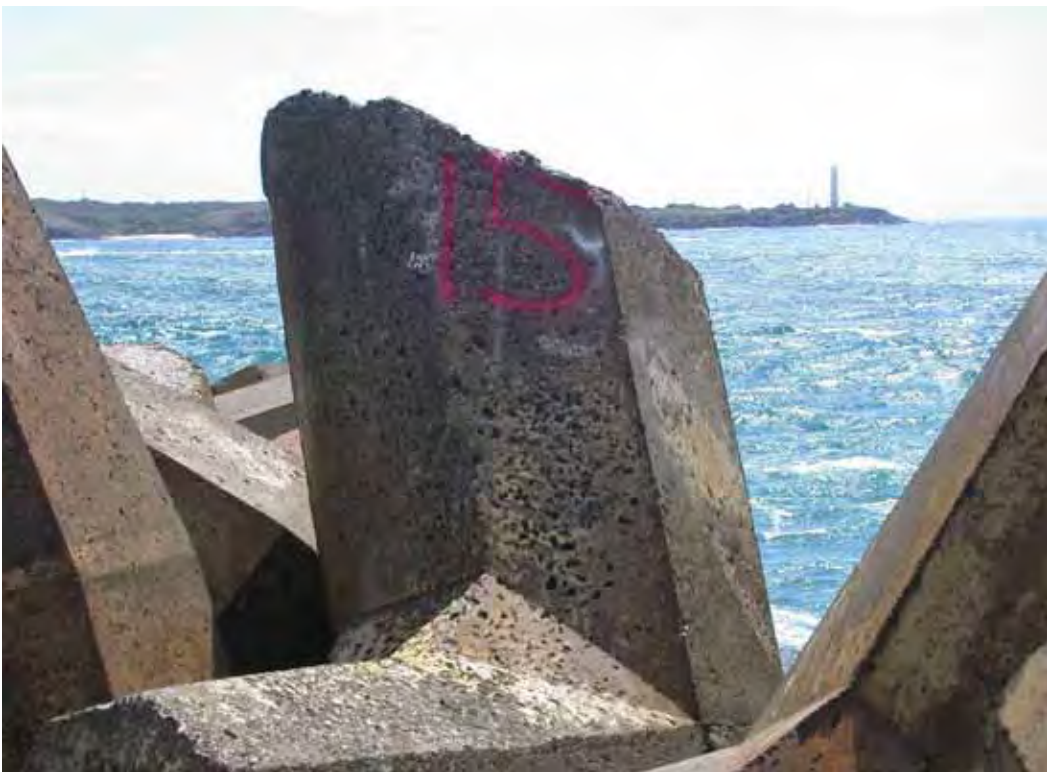
Figure D39. Damage location 45, sta 14+52, ocean side, rib #43, dolosse with shank-fluke break.

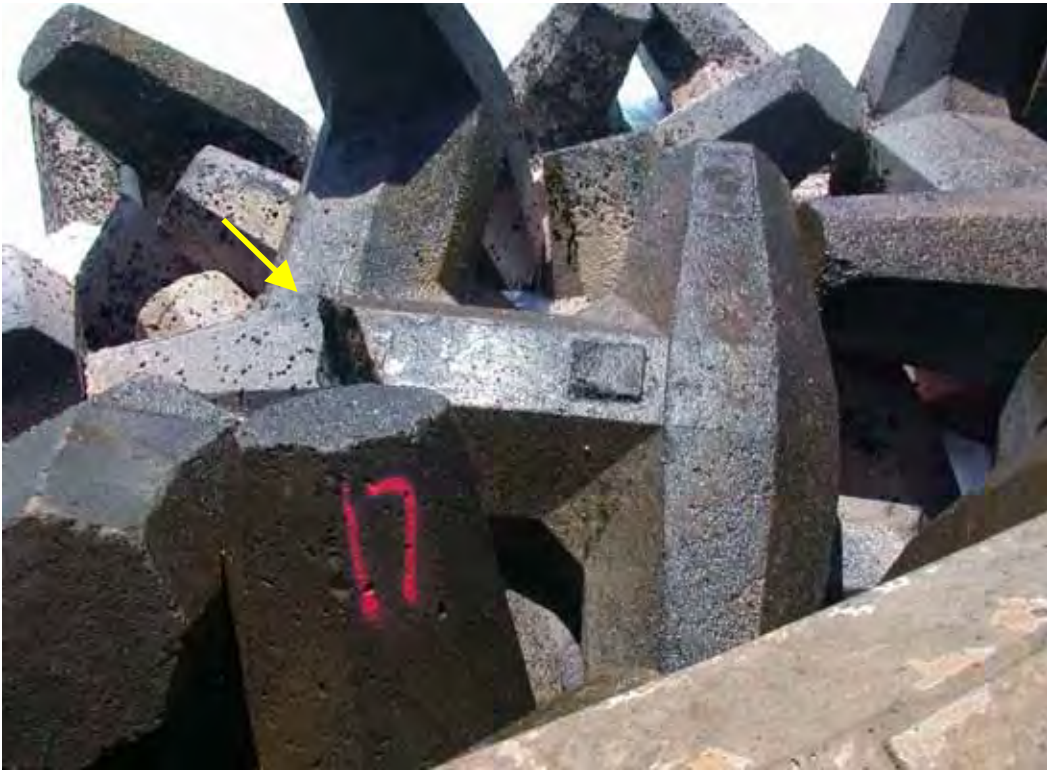
Figure D40. Damage location 49, sta 14+88, ocean side, rib #49, dolosse with fluke-shank break.

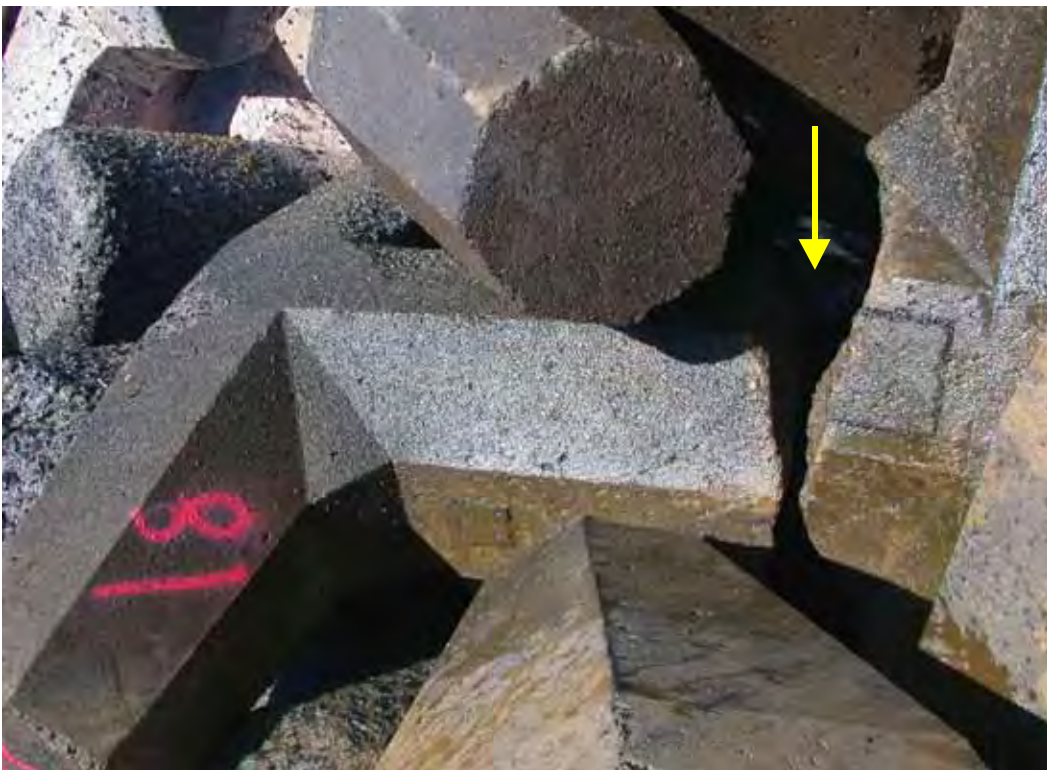
Figure D41. Damage location 50, sta 14+94, ocean side, rib #50, dolosse with shank-fluke break.

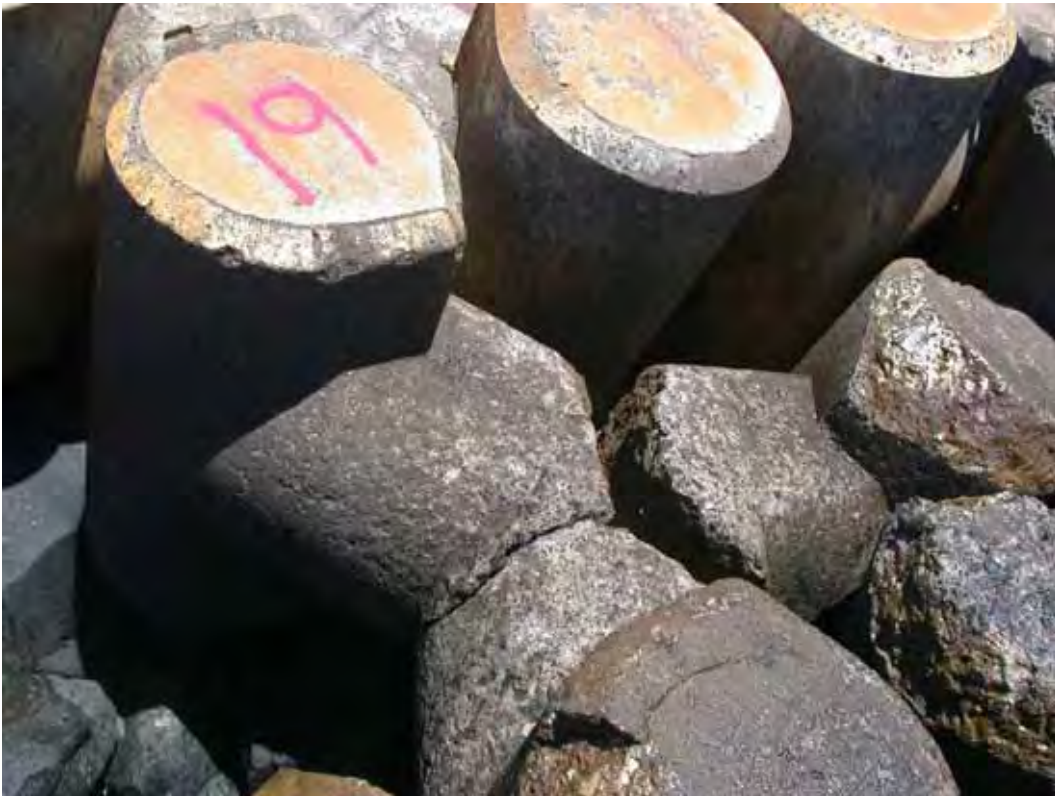
Figure D42. Damage location 51, sta 15+00, ocean side, rib #51, tribar with 3-way split.

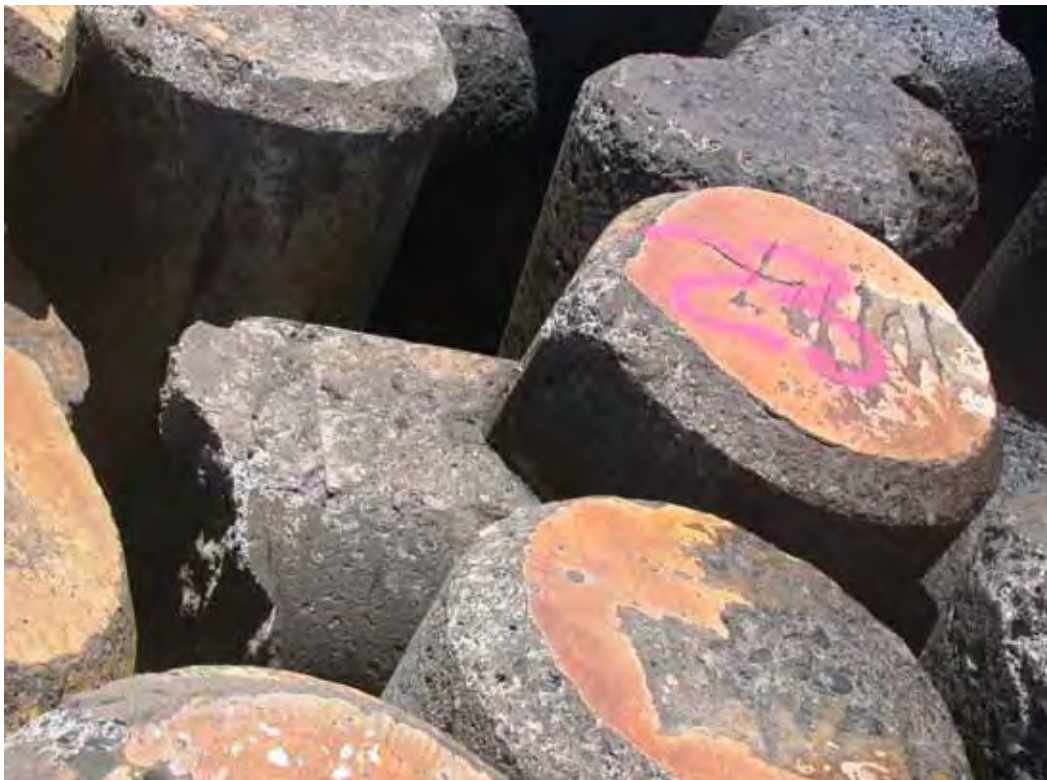
Figure D43. Damage location 55, sta 15+60, ocean side, rib #61, tribar with 3-way break at center.

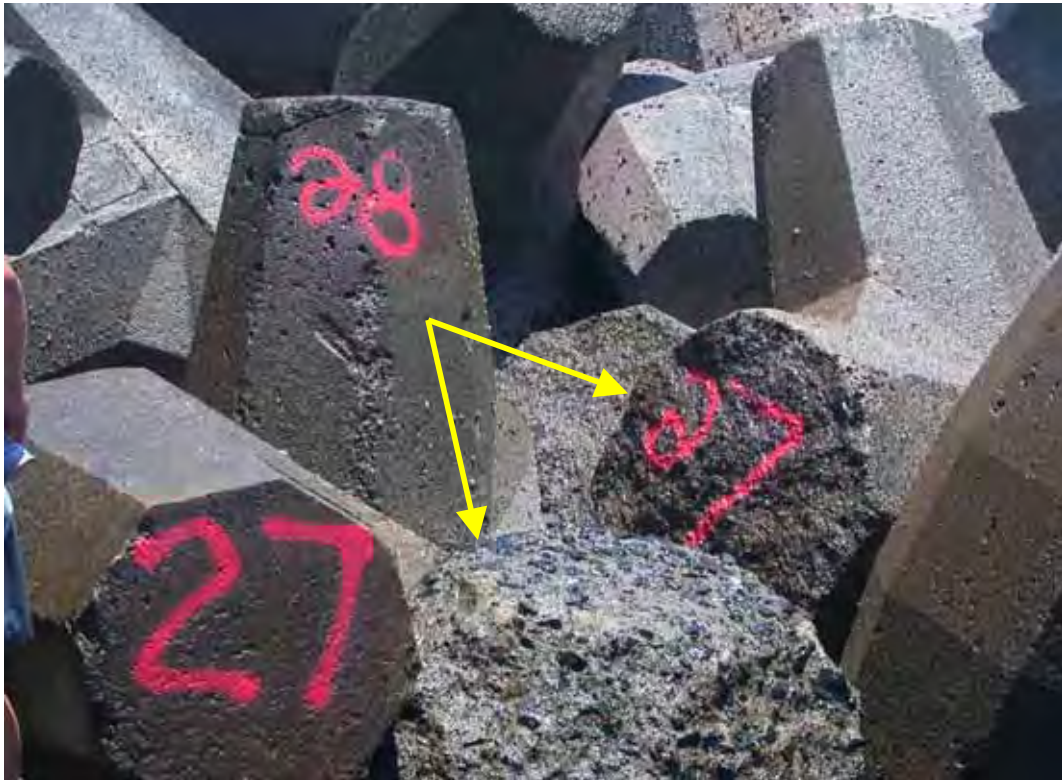
Figure D44. Damage locations 59 & 60, sta 15+96 – 16+02, ocean side, rib #67 & 68, two dolosse with mid-shank breaks.

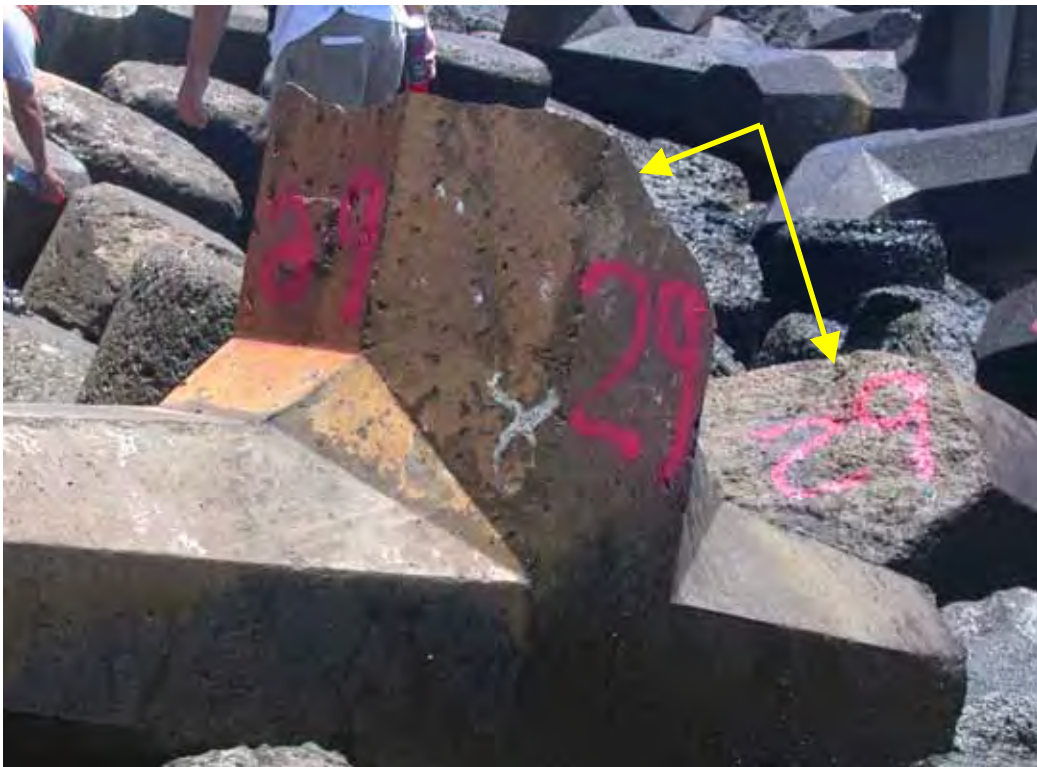
Figure D45. Damage location 61, sta 16+02, ocean side, rib #68, dolosse with mid-shank break.

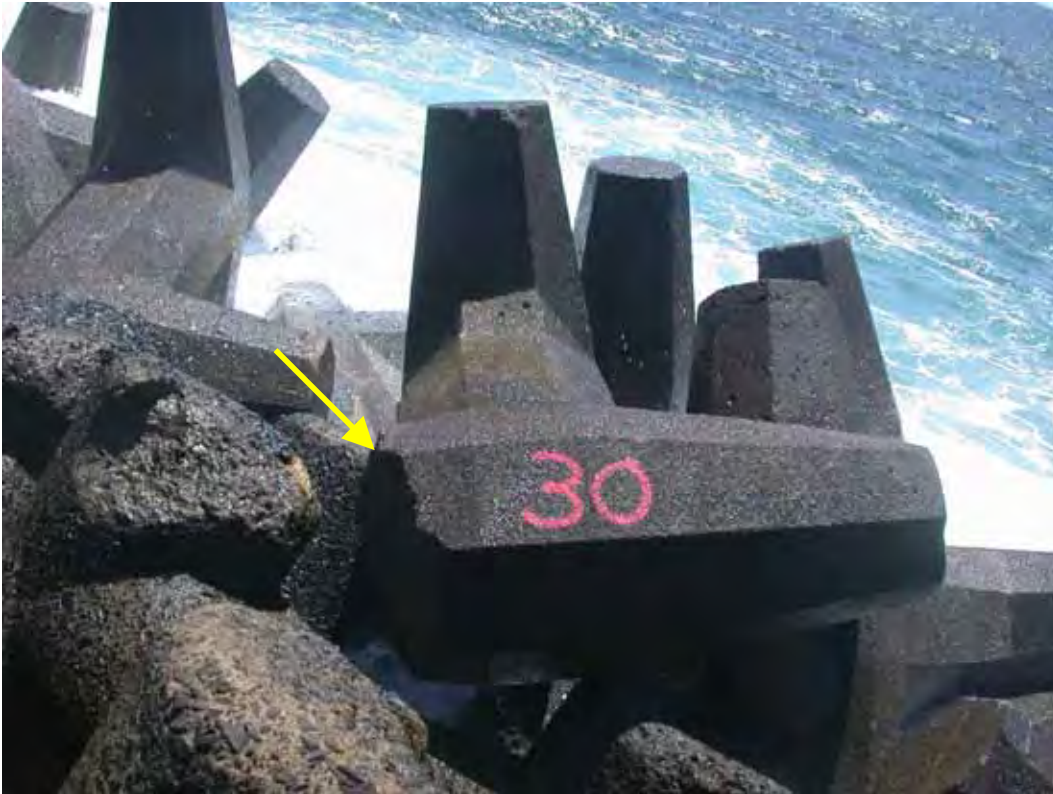
Figure D46. Damage location 63, sta 16+14, ocean side, rib #70, dolosse with fluke tip break.

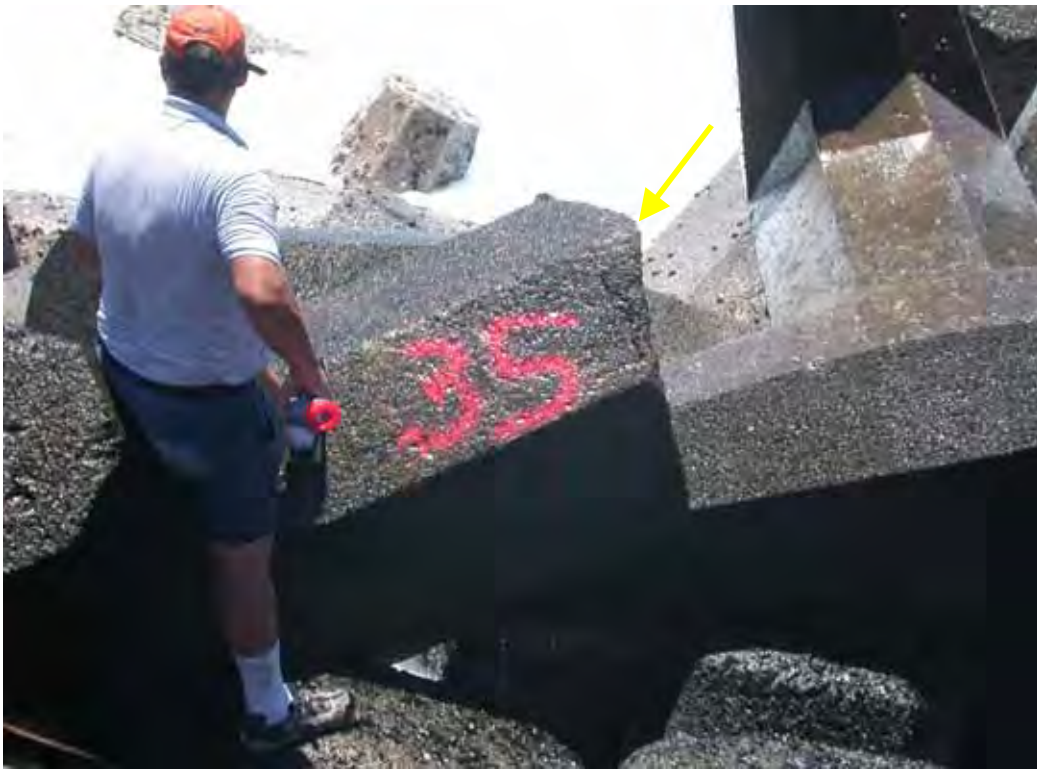
Figure D51. Damage location 67, sta 16+74, ocean side, rib #80, dolosse with shank-fluke break.

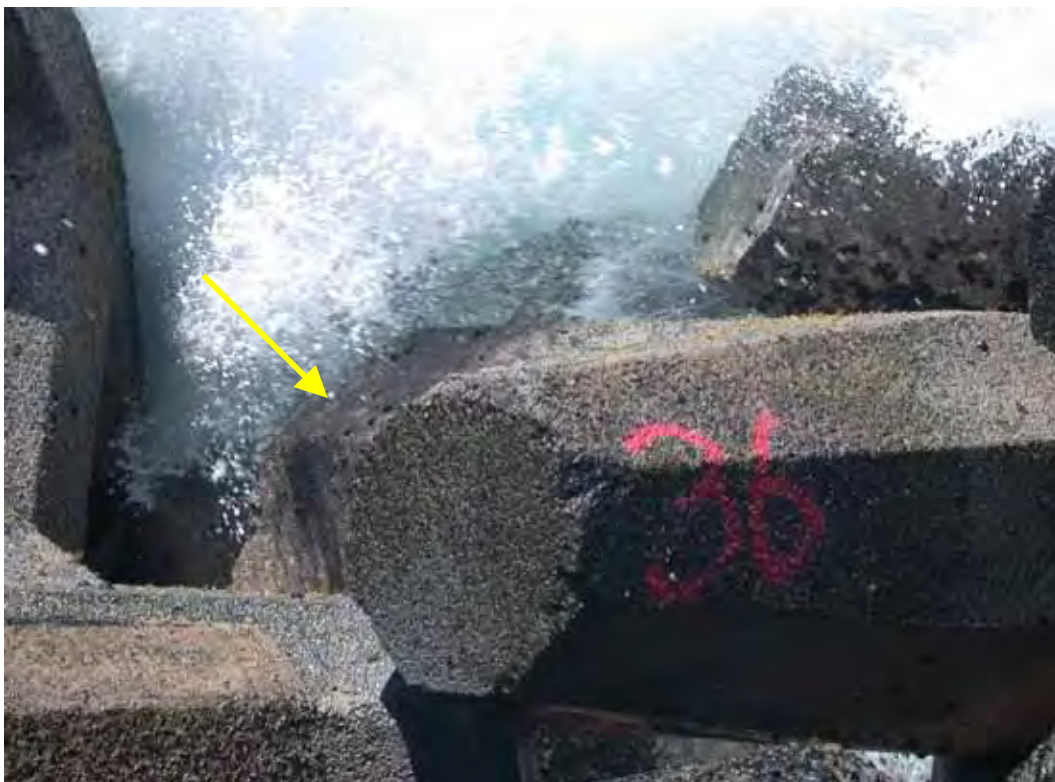
Figure D52. Damage location 68, sta 16+80, ocean side, rib #81, dolosse with shank-fluke break.

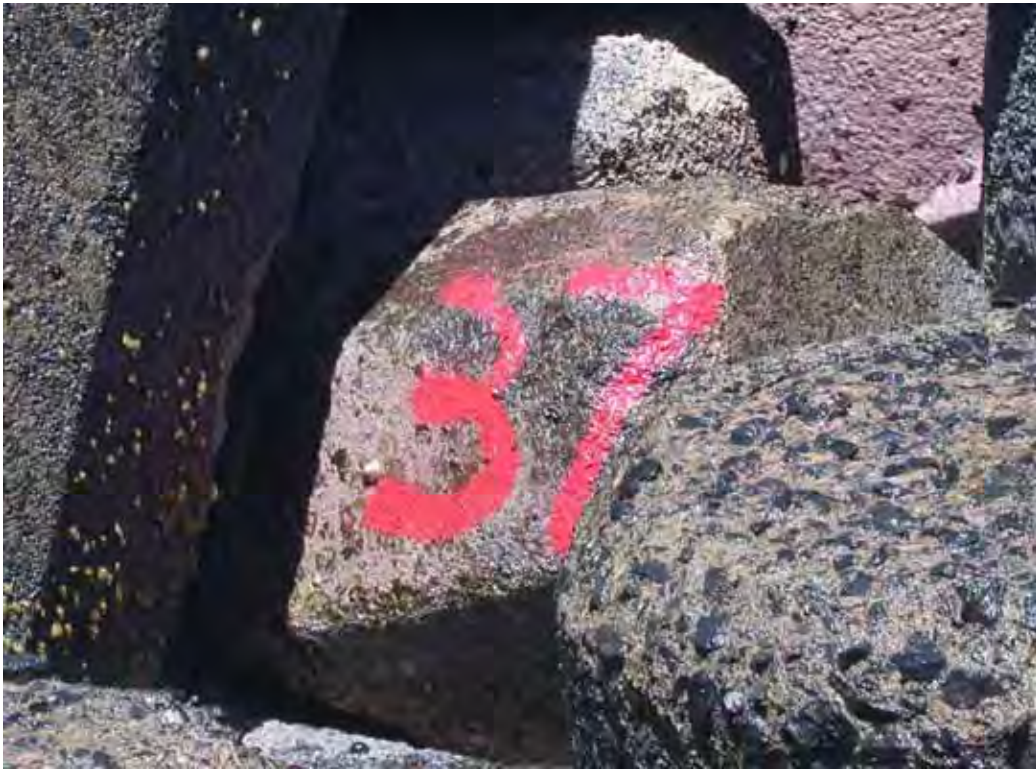
Figure D53. Damage location 69, sta 16+98, ocean side, rib #84, detached dolosse fluke tip, origin unknown.

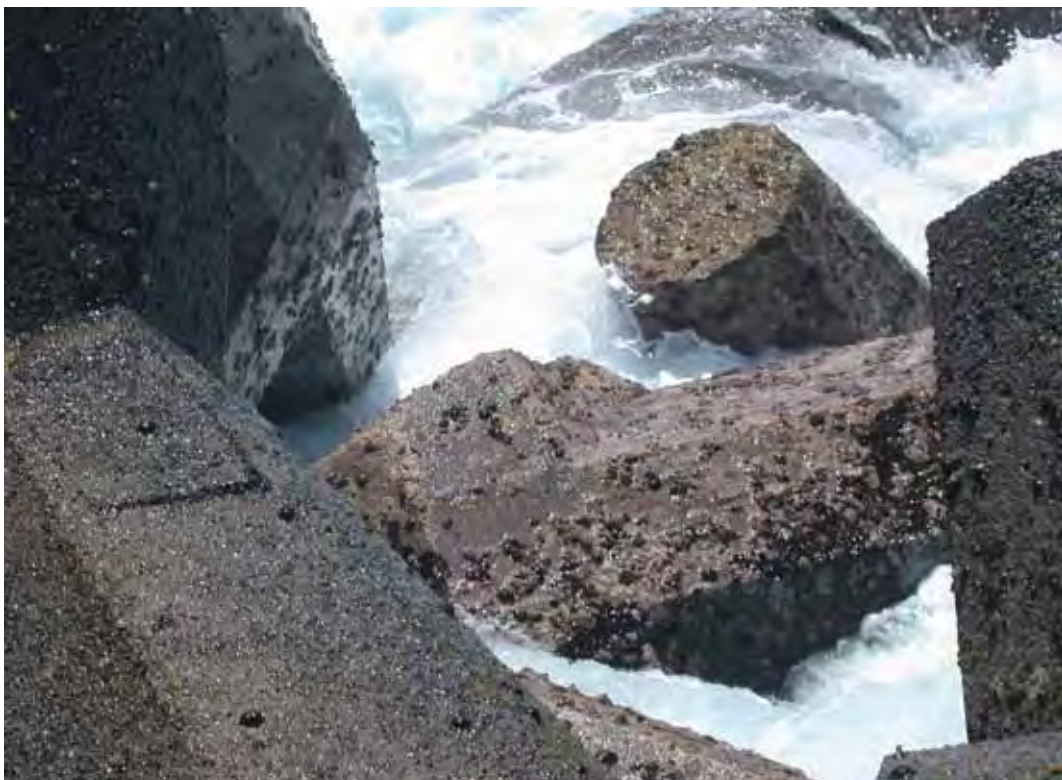
Figure D54. Damage location 71, sta 17+22, ocean side, rib #88, dolosse with multiple breaks at waterline.

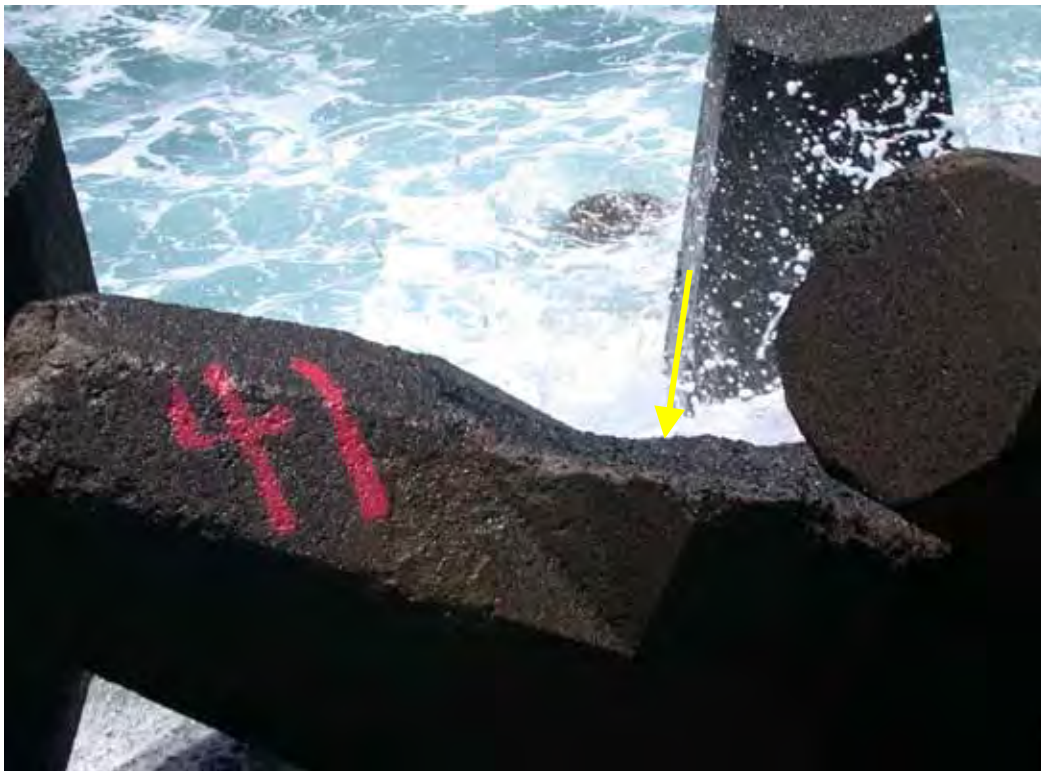
Figure D55. Damage location 73, sta 17+58, ocean side, rib #94, dolosse with shank-fluke break.

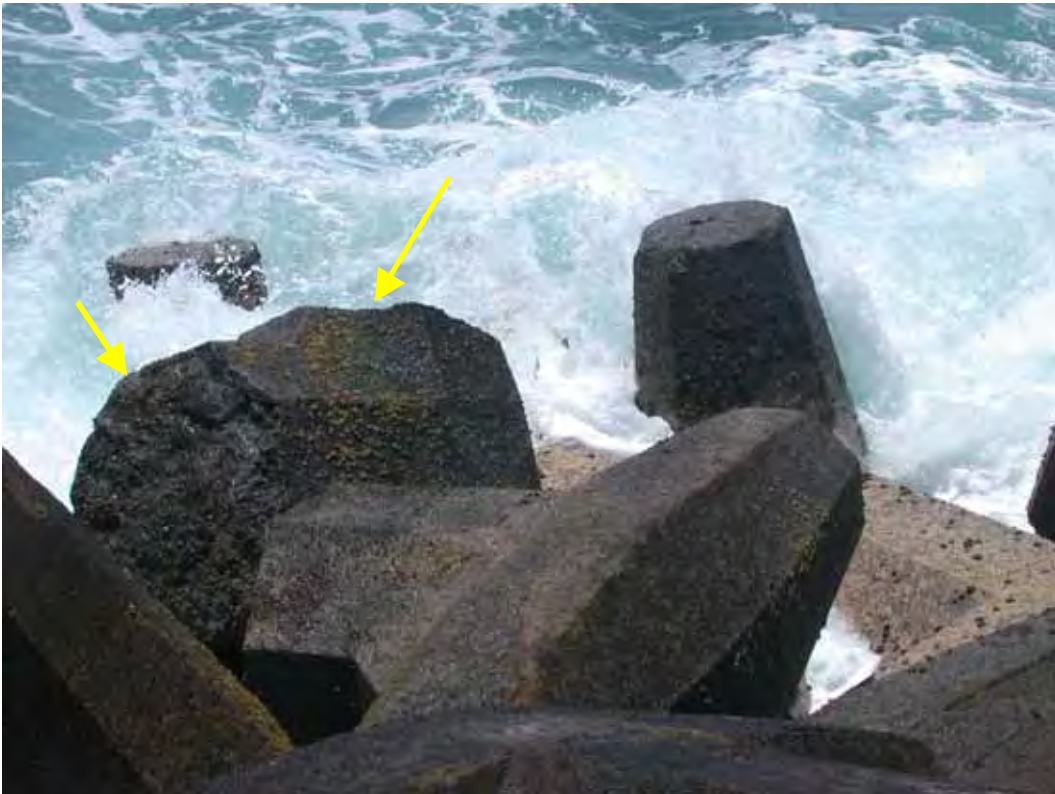
Figure D58. Damage location 76, sta 18+24, ocean side, rib #105, dolosse with fluke tip break.

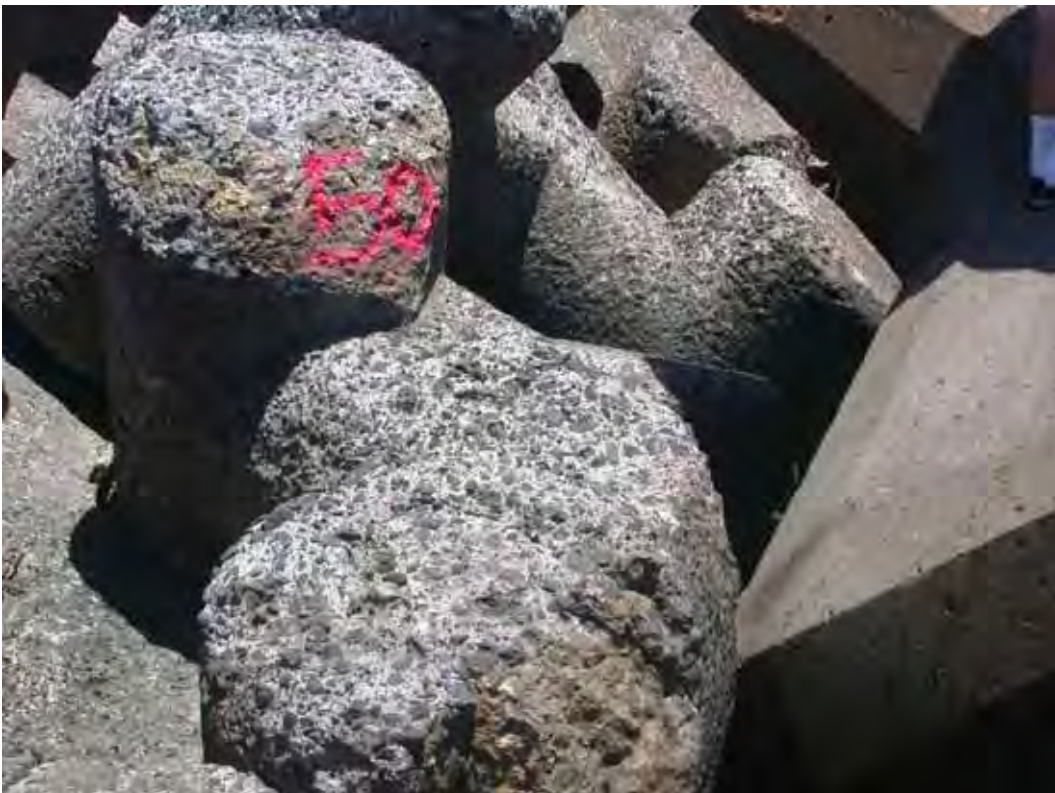
Figure D60. Damage location 81, sta 18+72, ocean side, rib #113, tribar with broken can.

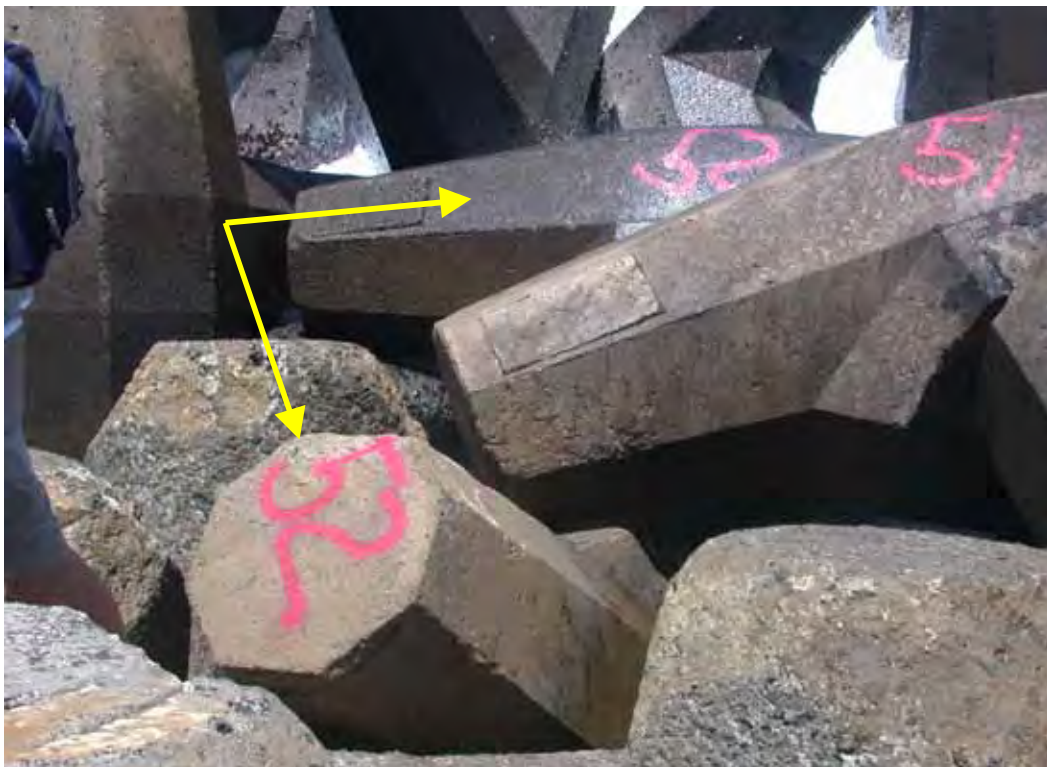
Figure D62. Damage location 83, sta 19+08, ocean side, rib #119, dolosse with shank-fluke break.

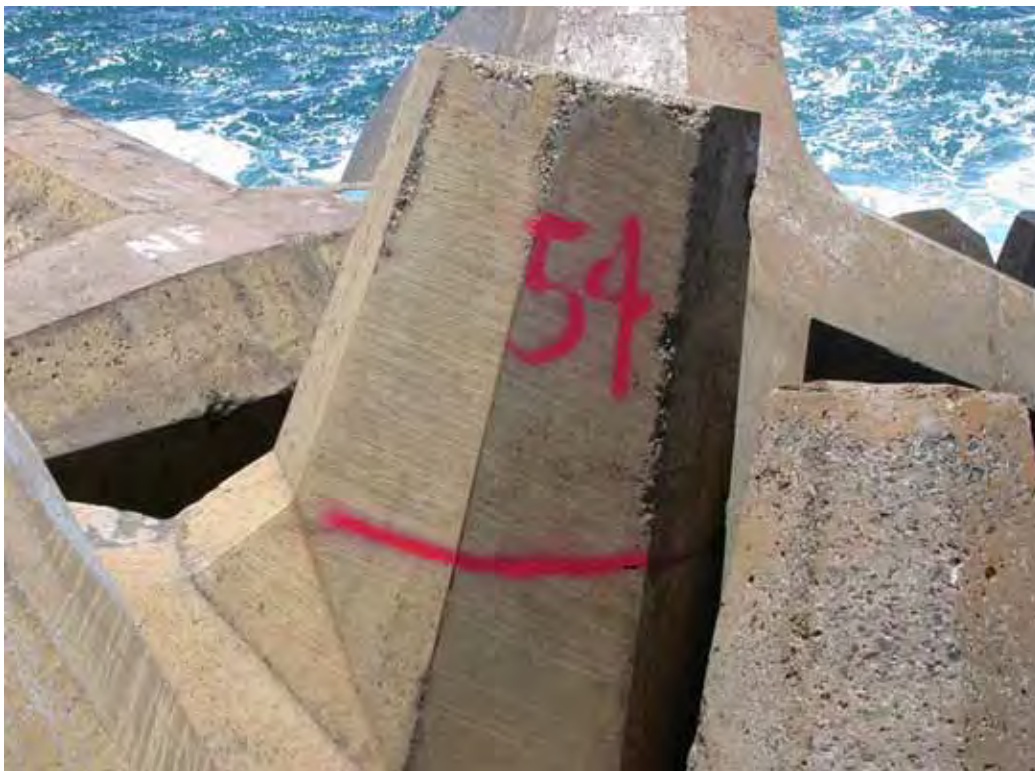
Figure D64. Damage location 85, sta 19+20, ocean side, rib #121, tribar broken through center.

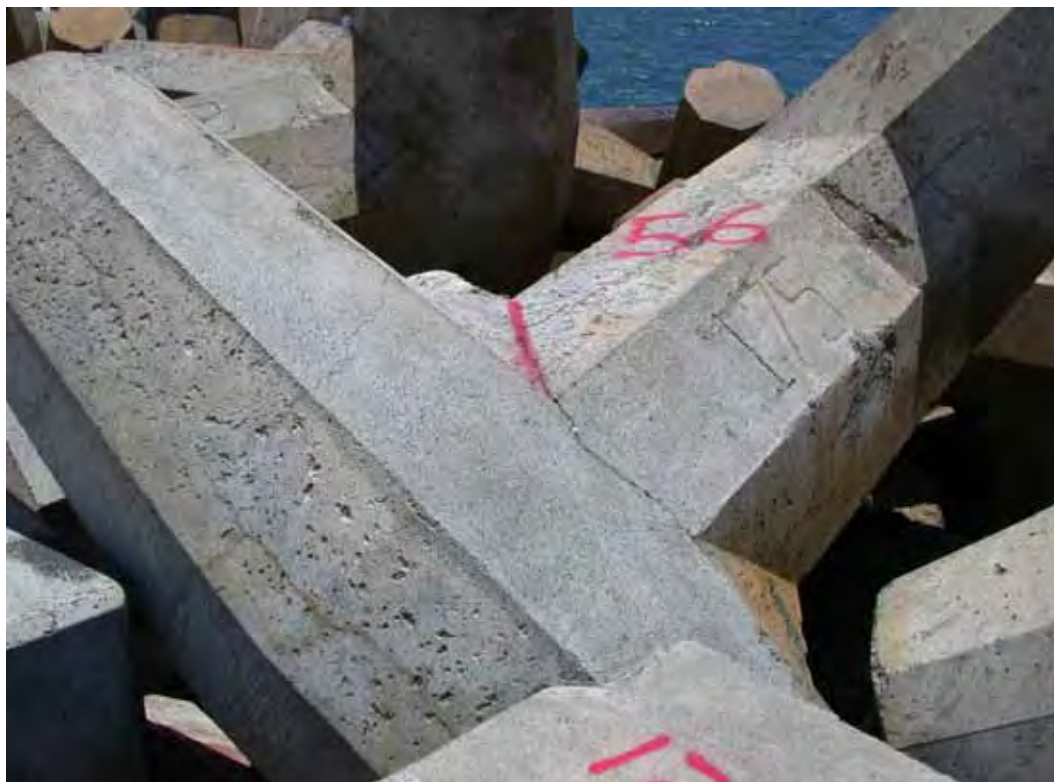
Figure D66. Damage location 88, sta 19+48, ocean side, rib #124, tribar with broken leg.

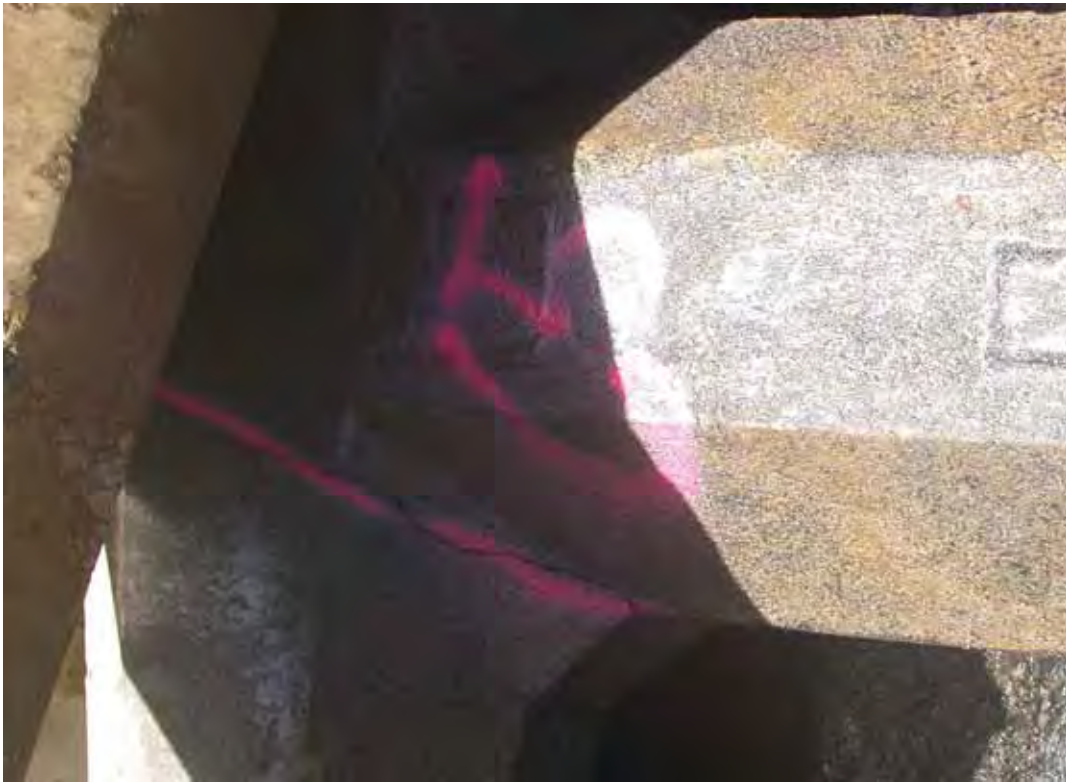
Figure D71. Damage location 96, sta 19+90, ocean side, rib #131, dolosse with shank break.

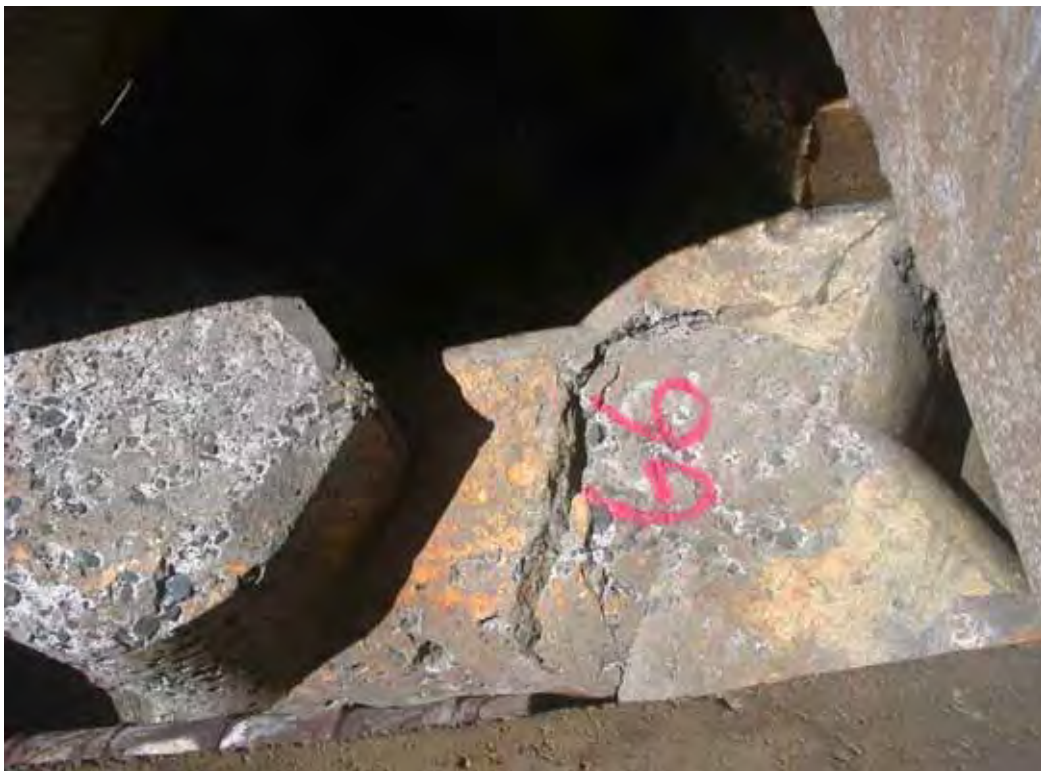
Figure D72. Damage location 97, sta 19+96, ocean side, rib #132, dolosse with fluke-shank crack.

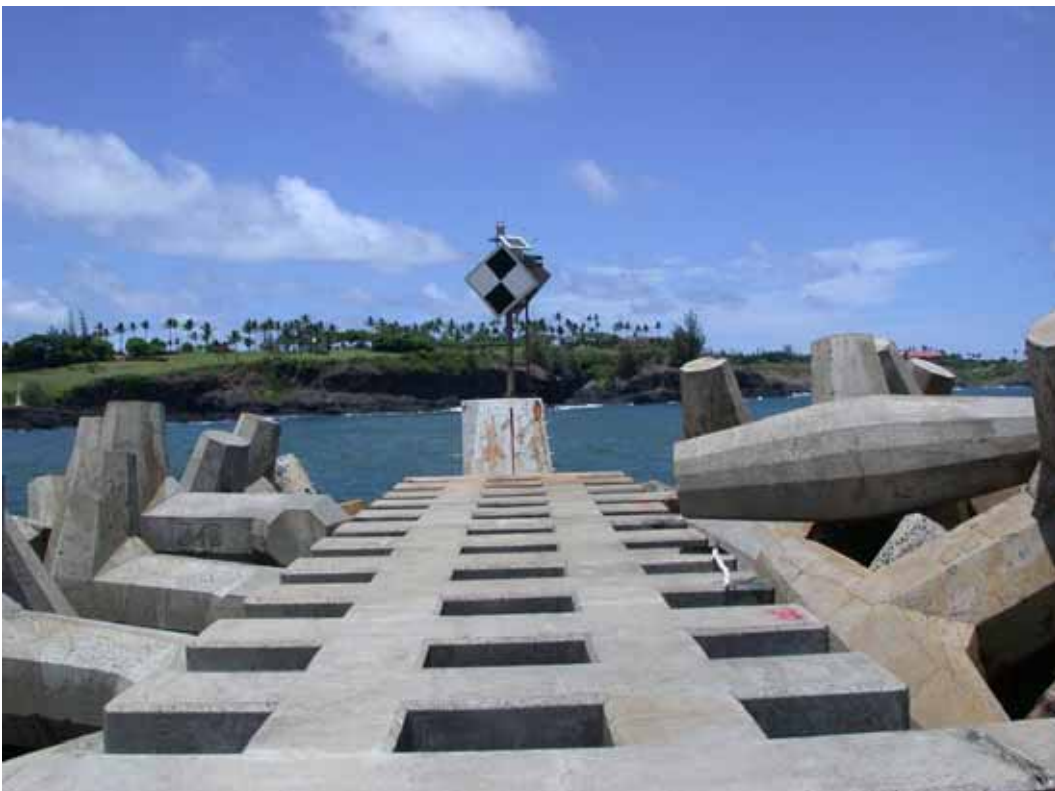
Figure D76. Damage location 107, sta 20+32, ocean side, rib #138, tribar with broken leg.

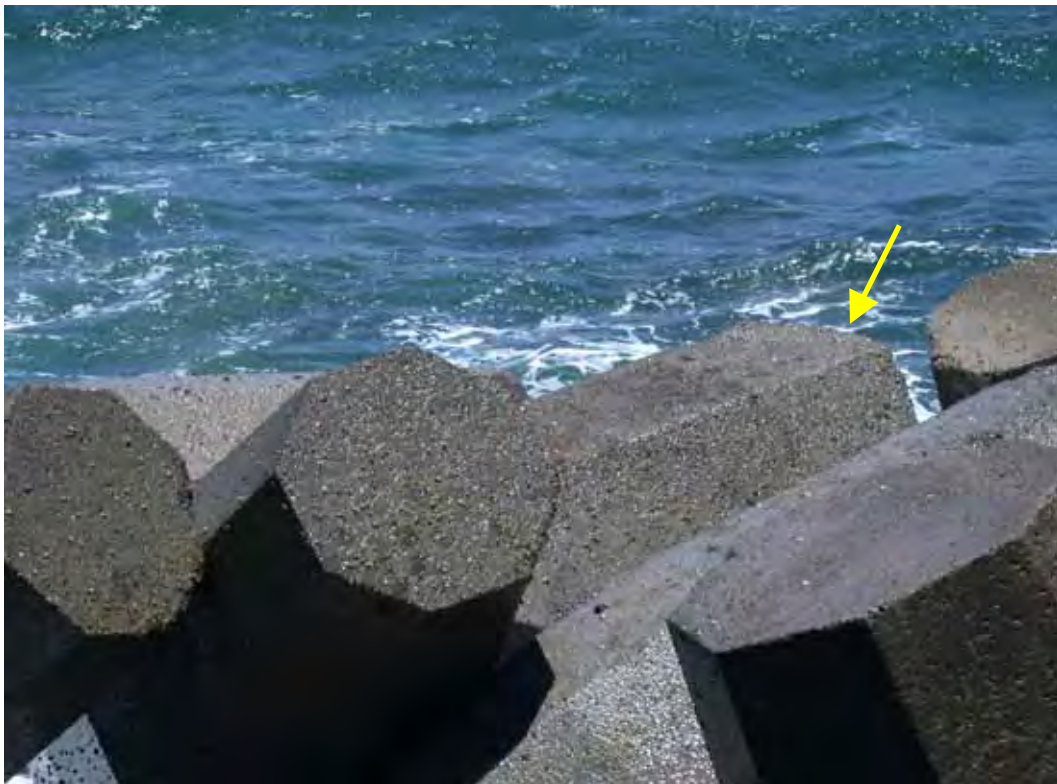
Figure D77. 0 deg is straight through centerline of head, end of crest is sta 20+45.

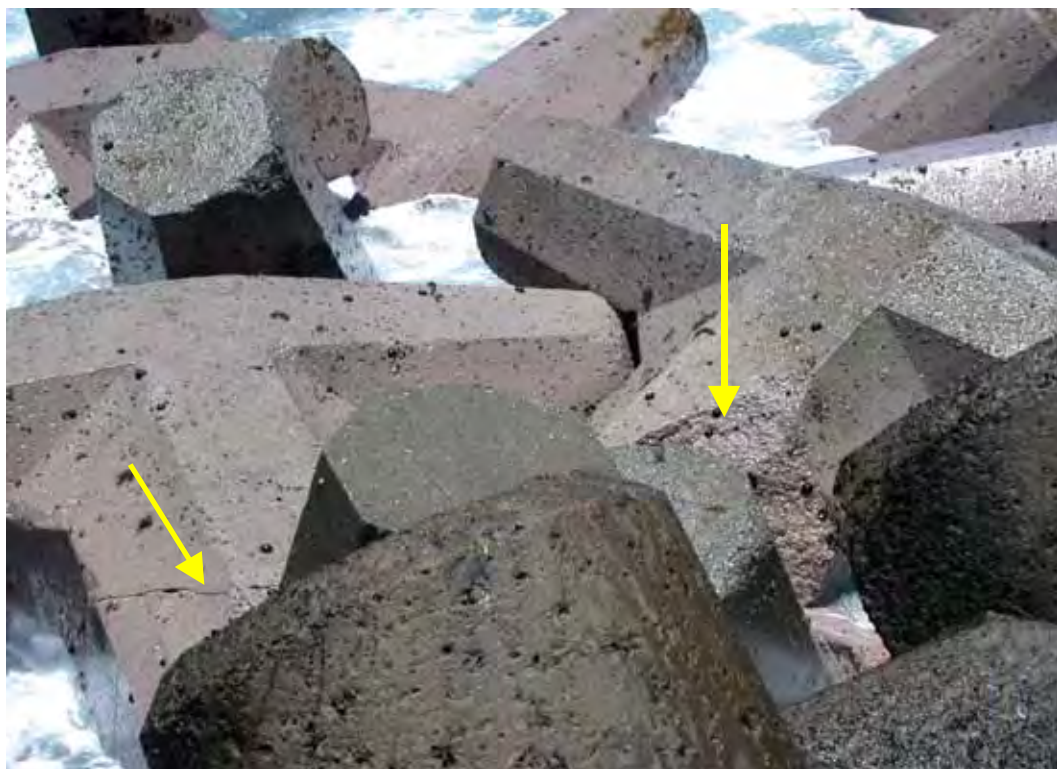
Figure D78. Damage location 108, 70 deg ocean side of head, dolosse with shank-fluke break at waterline.

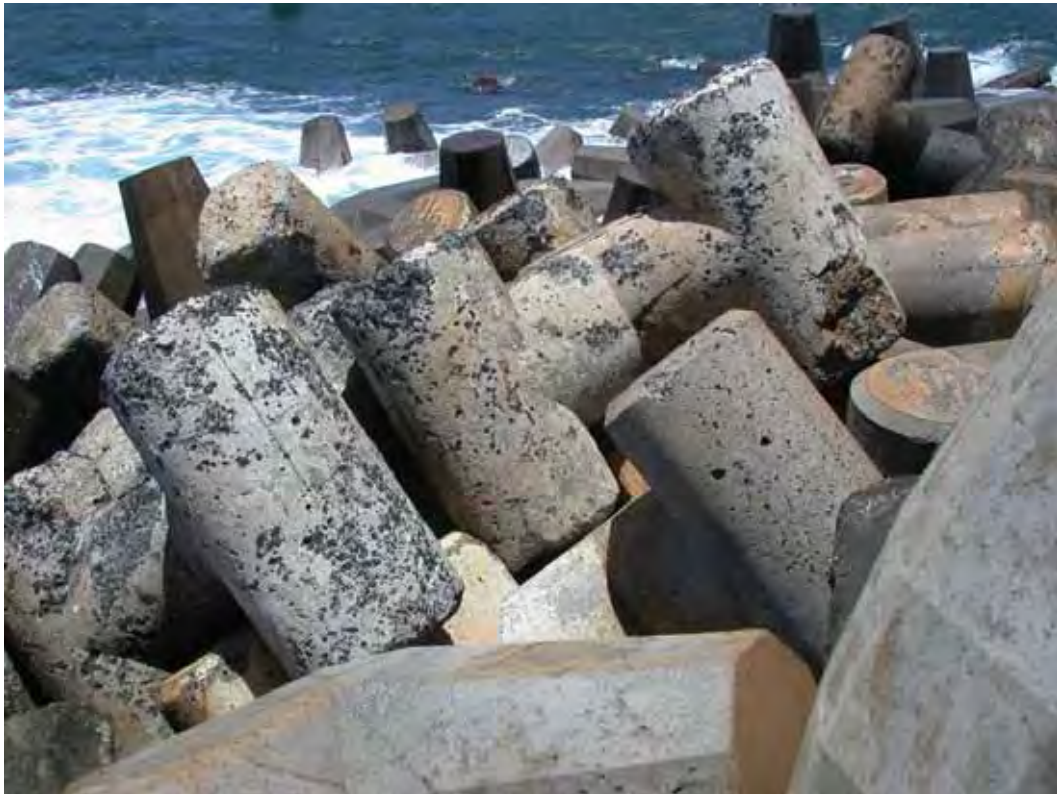
Figure D79. Damage locations 109 & 110, 25 deg harbor side of head, dolosse with shank crack and dolosse with shank break.
